Technical Note N-1450

EXPERIMENTAL POLYURETHANE FOAM ROOFING SYSTEMS

John R. Keeton, Robert L. Alumbaugh, Ph D,
and Edwin F. Humm

August 1976

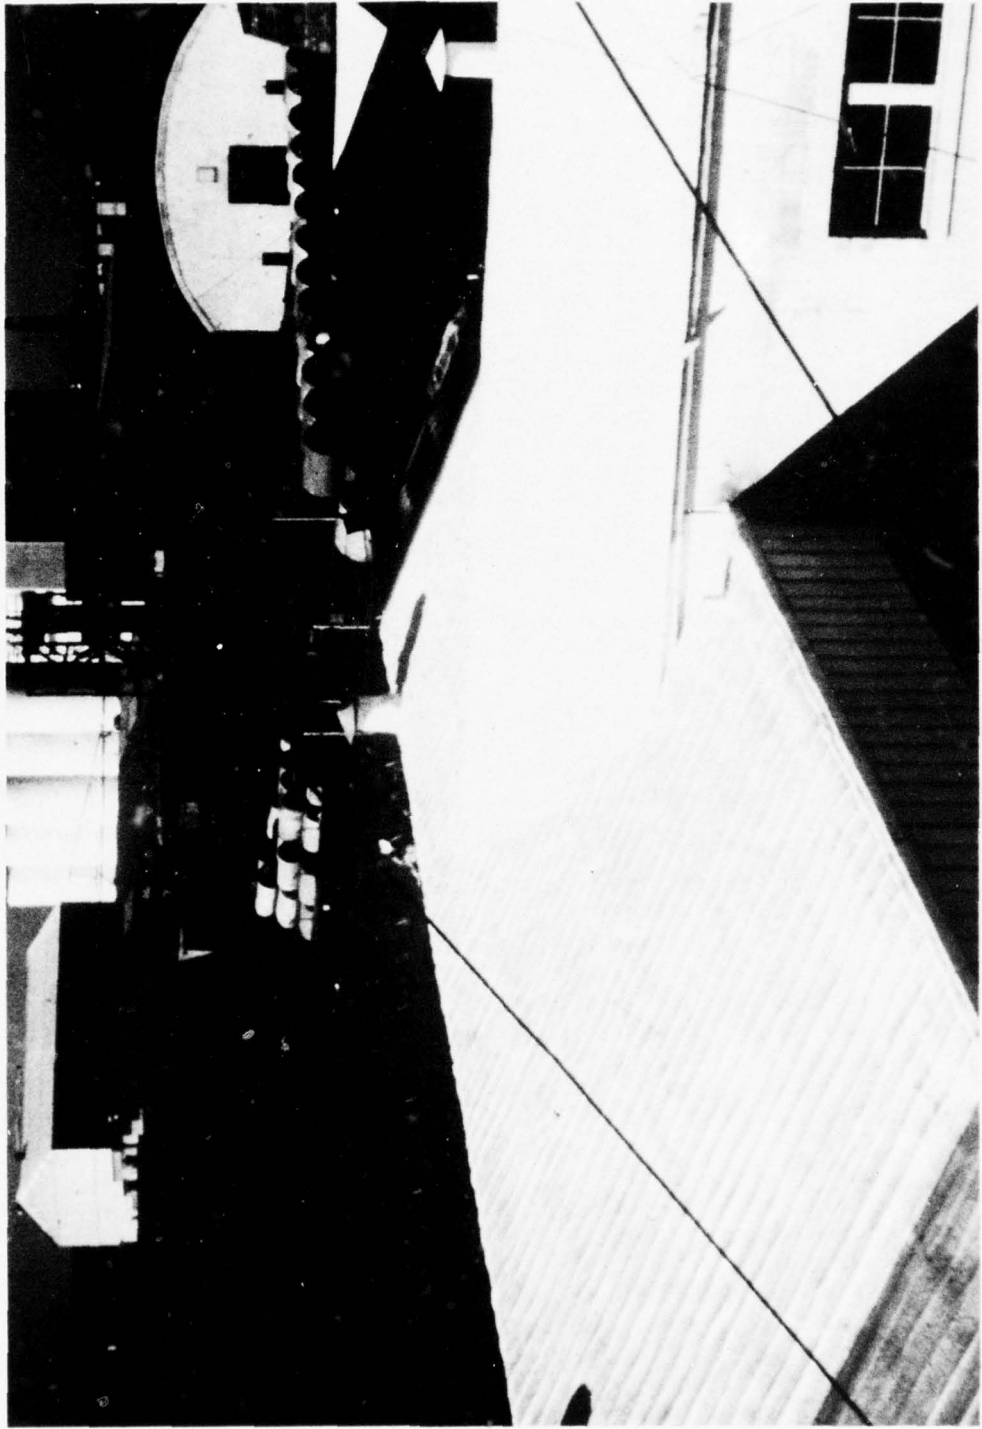
Figure 22. East Side of Junction of Boiler House and South Building

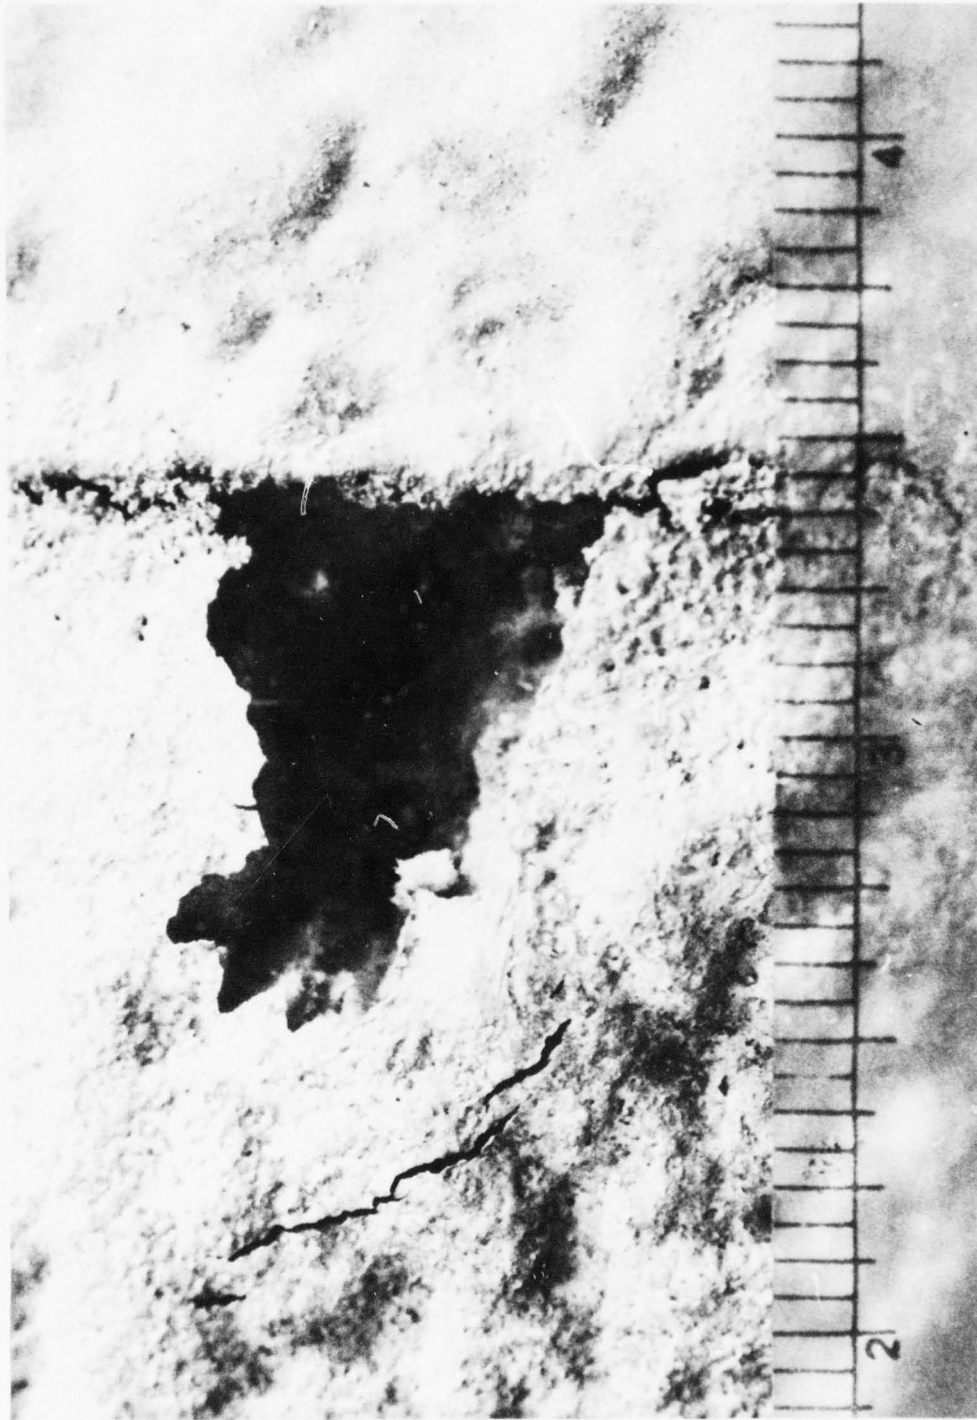
Figure 26. Close-up of Small Area Showing Bird Pecking in System 1 Section After 22 Months of Weathering

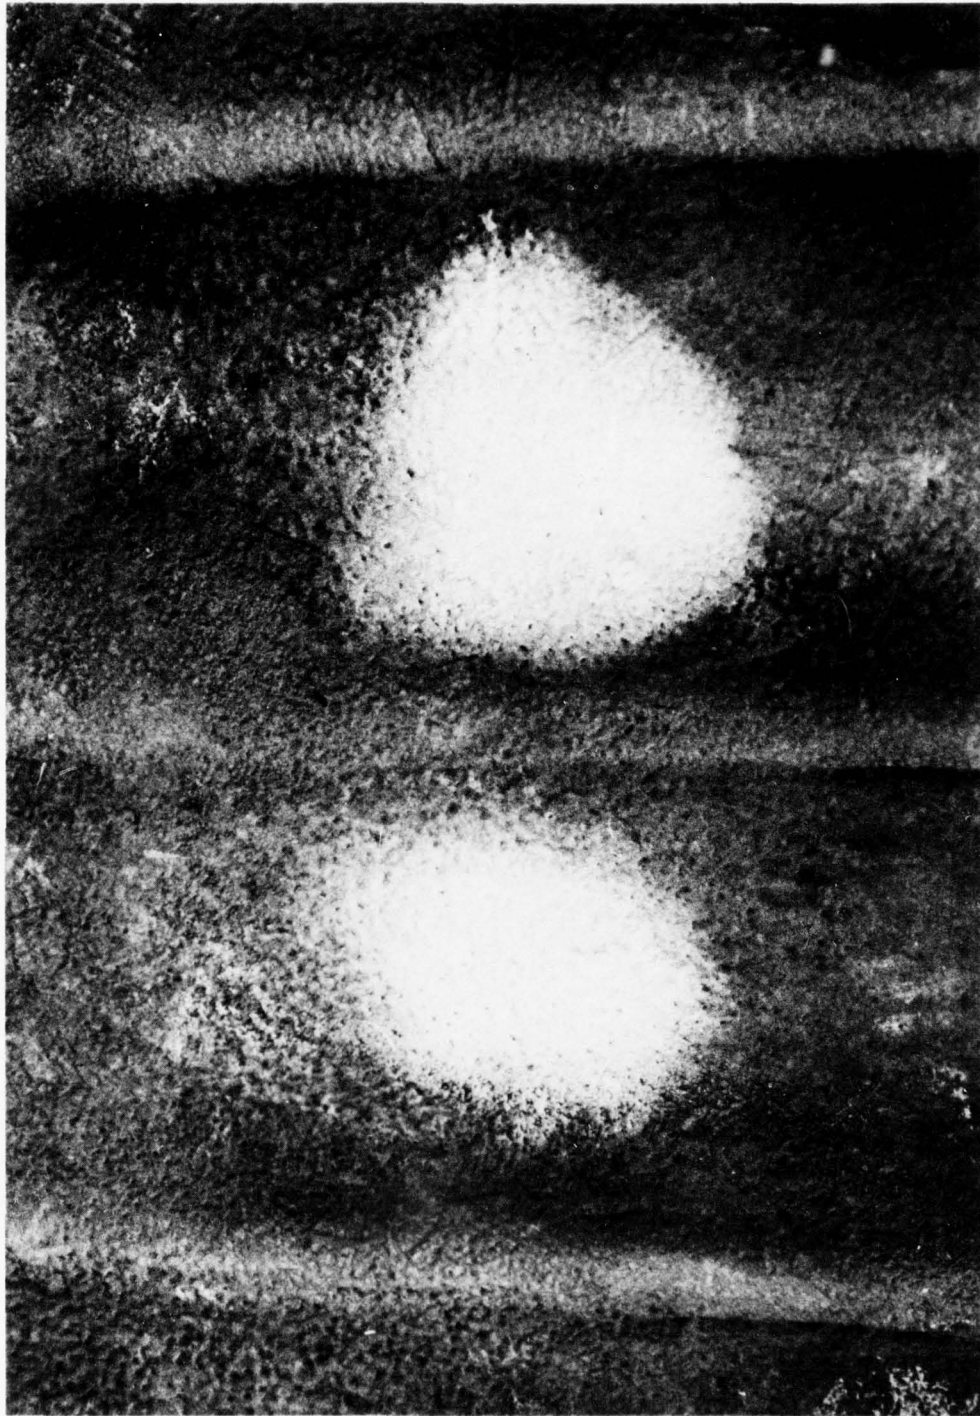
Figure 29. Two Cleaned Spots in System 2 Coating That Show Extent of Dirt Retention
by Moisture-Curing Silicone Rubber Coating

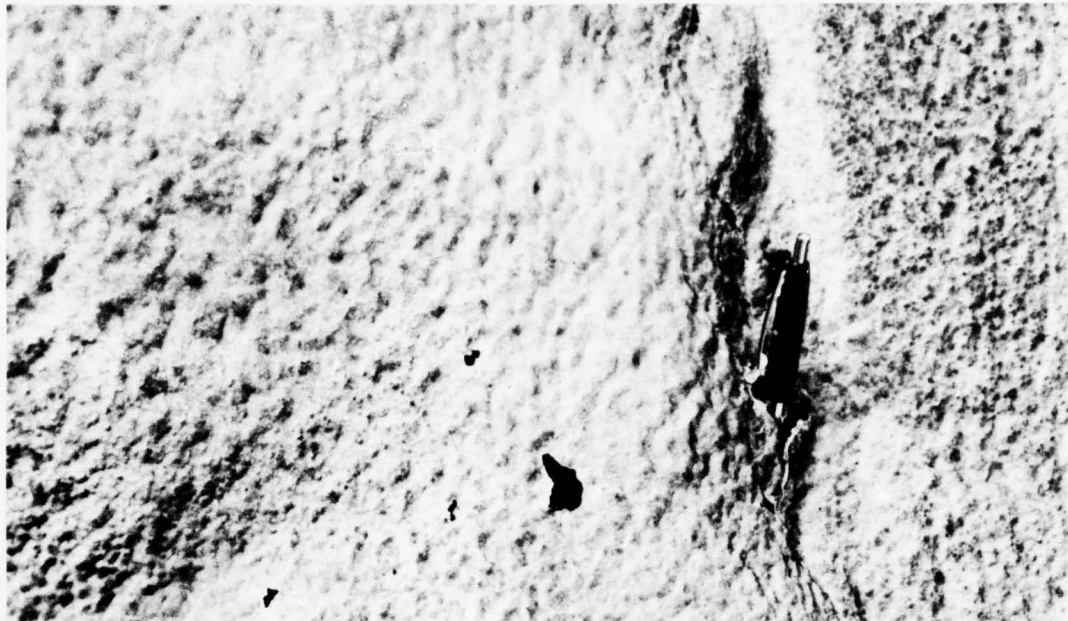
(a) Small Holes in Coating (Note Pen Protruding From Coating).

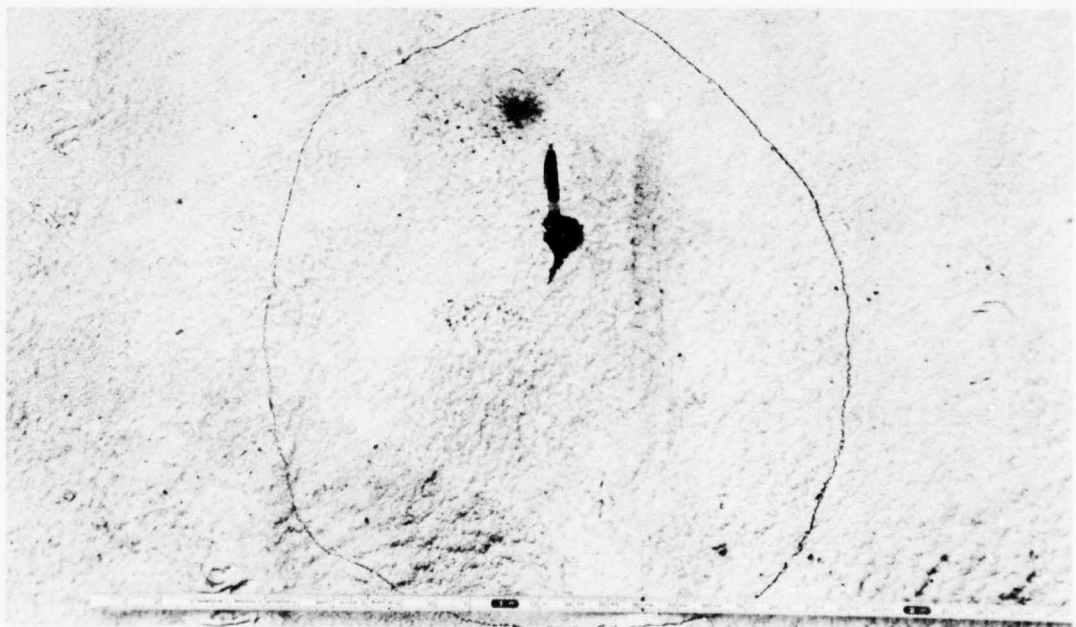
This system also had the largest areas in the experimental roof systems with poor quality foam. These are shown in Figure 32 and Figure 33. Figure 32 shows an area of about 10 square feet of spongy foam, while Figure 33 shows a relatively small area with blistered foam just below the area of spongy foam. In the latter case, the top lift of the foam had blistered from the lift underneath. These areas are believed to have been caused by improper proportioning of components of the foam during application. These areas have also been satisfactorily repaired by the contractor, and their repair is described in a following section.

Figure 33. Area of Blistered Foam on North Side of System 3 Section
After 9 Months of Weathering

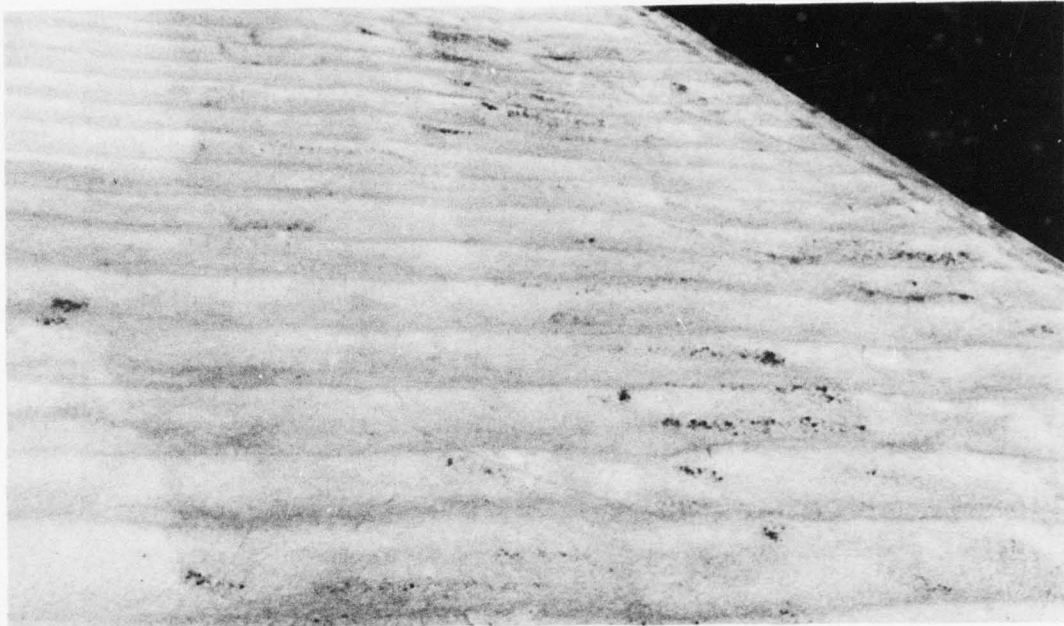
Figure 36. Area of Hypalon Mastic (System 4) Showing Greatest Erosion Damage After 22 Months of Weathering

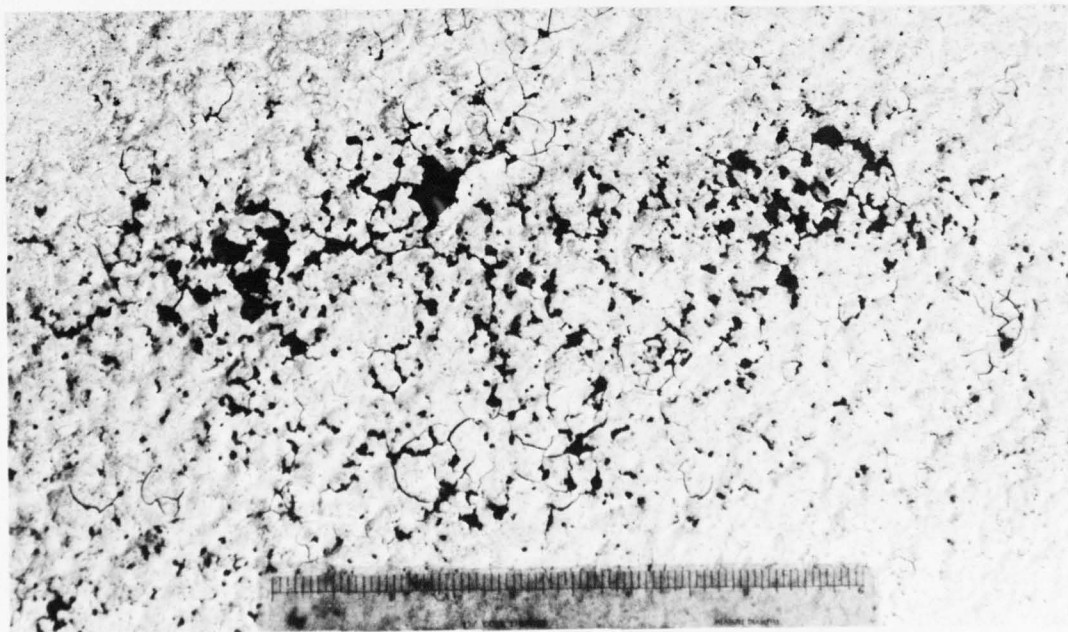
Figure 37. Close-up of Badly Eroded Portion of Hypalon Mastic, (System 4) After 22 Months of Weathering

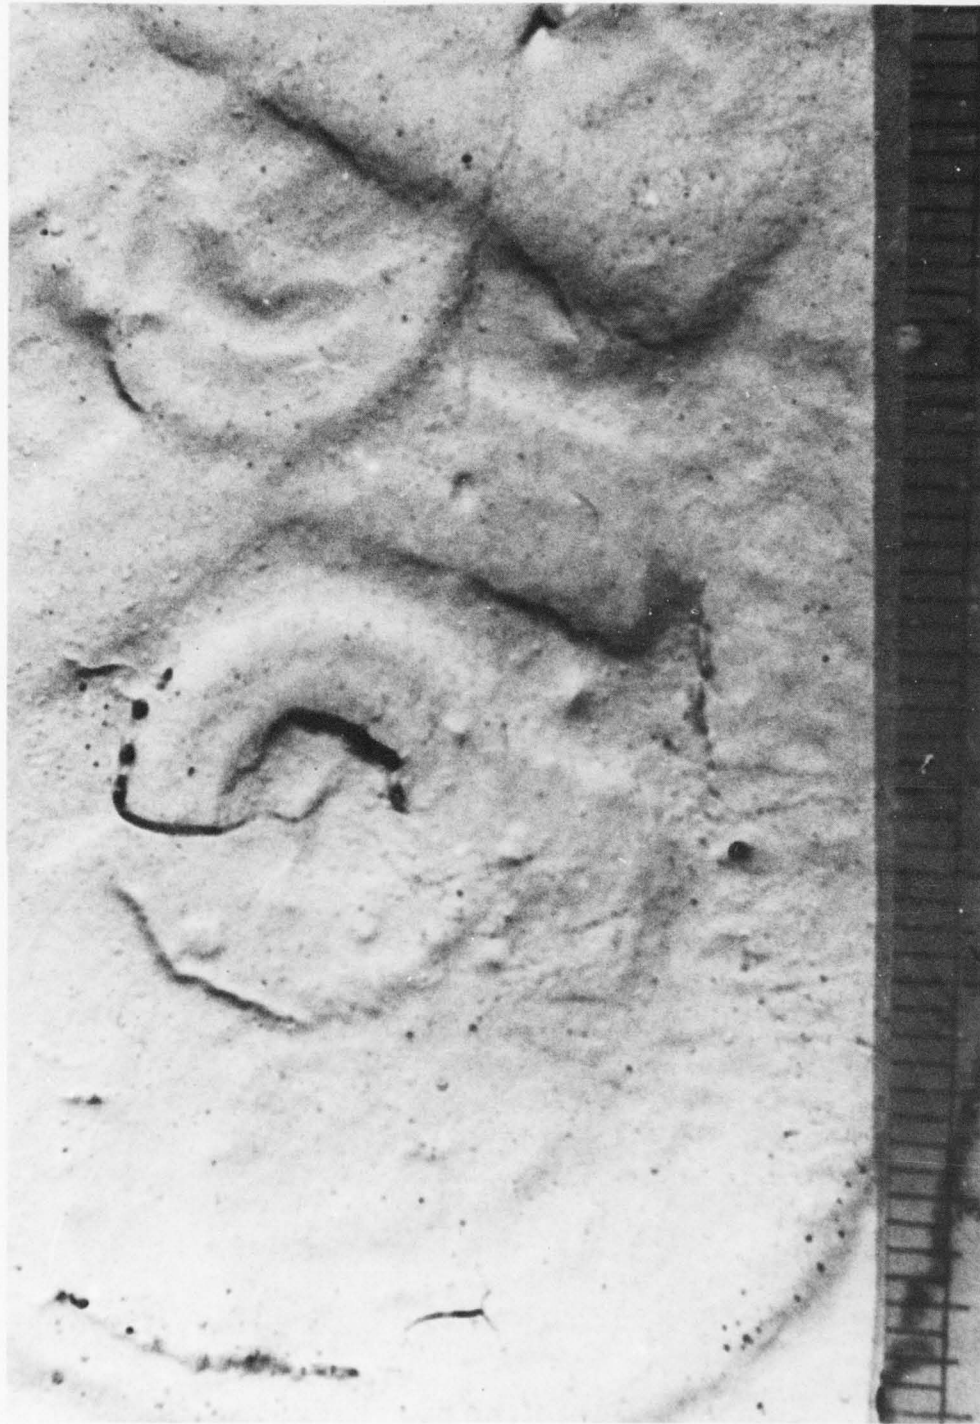
Figure 38. Cracking of Hypalon Mastic (System 4) in Heelprint After 22 Months of Weathering

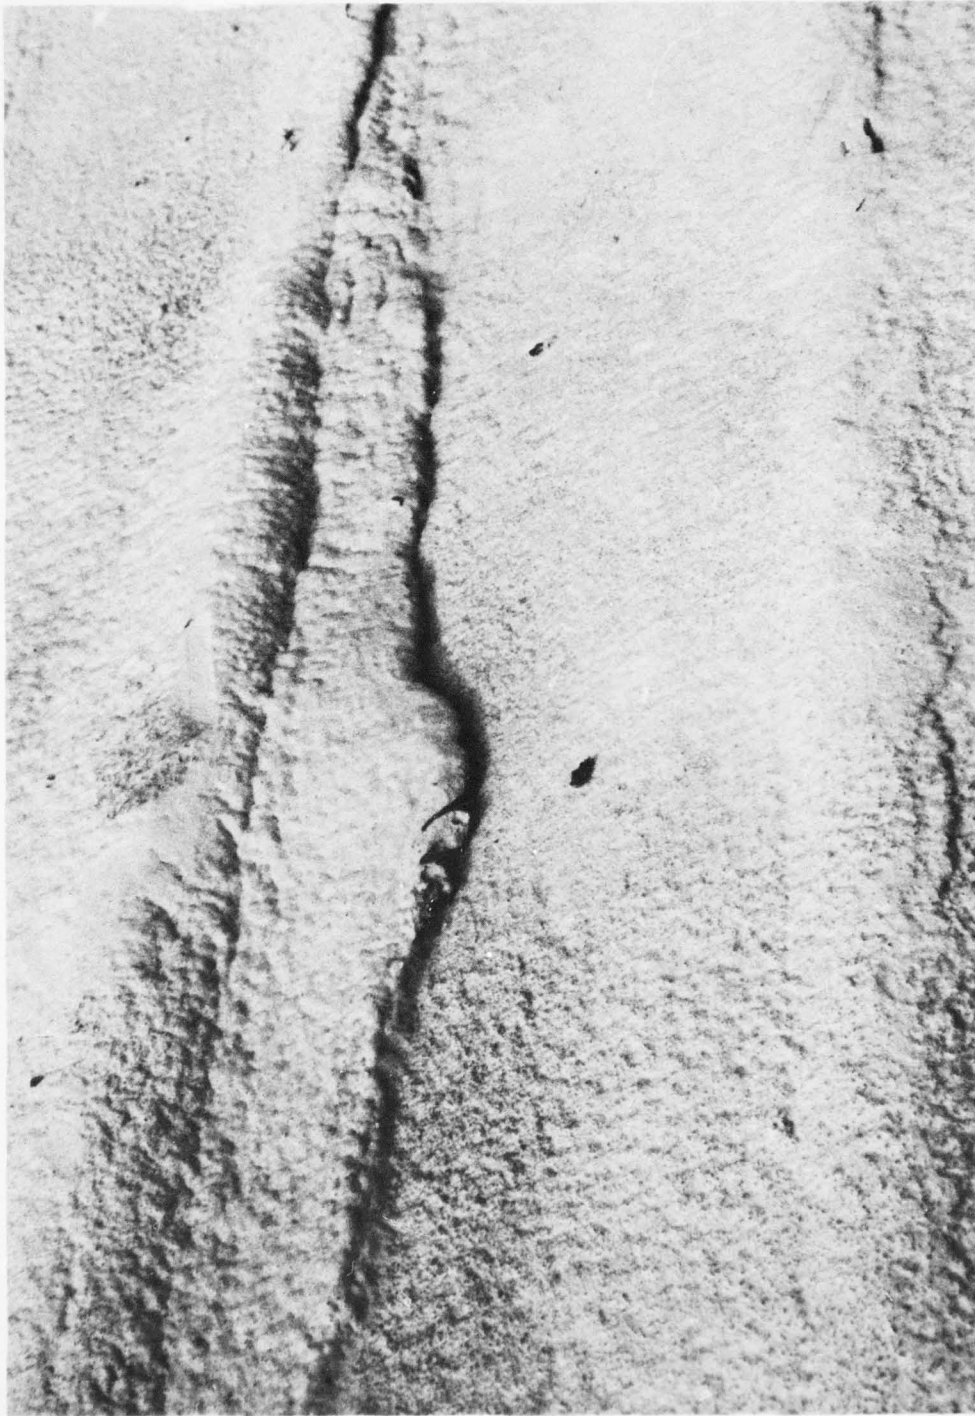
Figure 39. Poorly Constructed Overlap Joint Between System 3 Section and System 4 Section

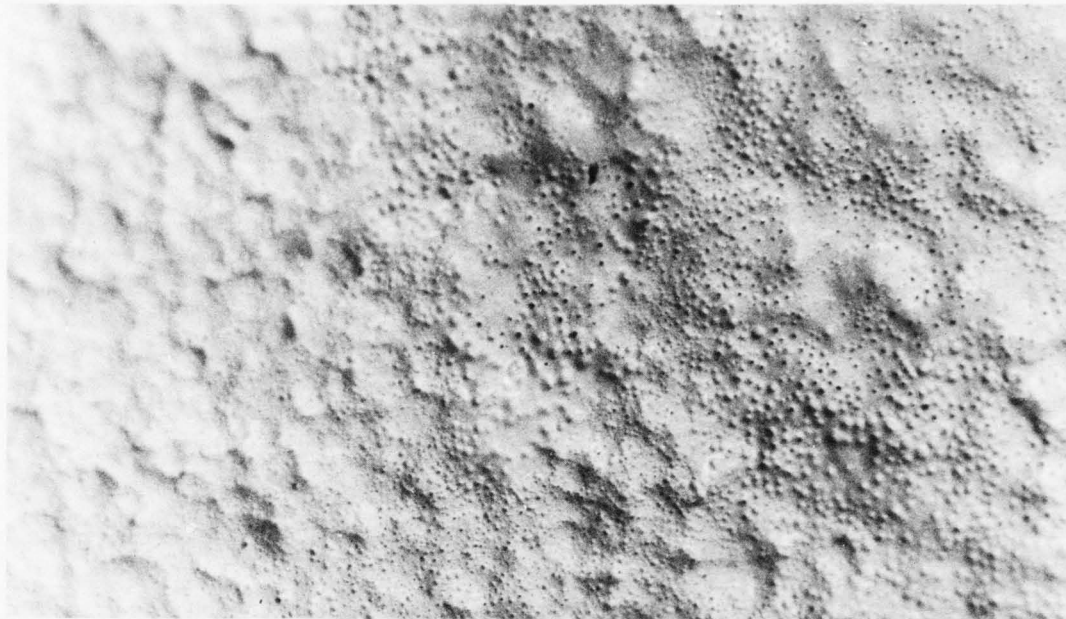
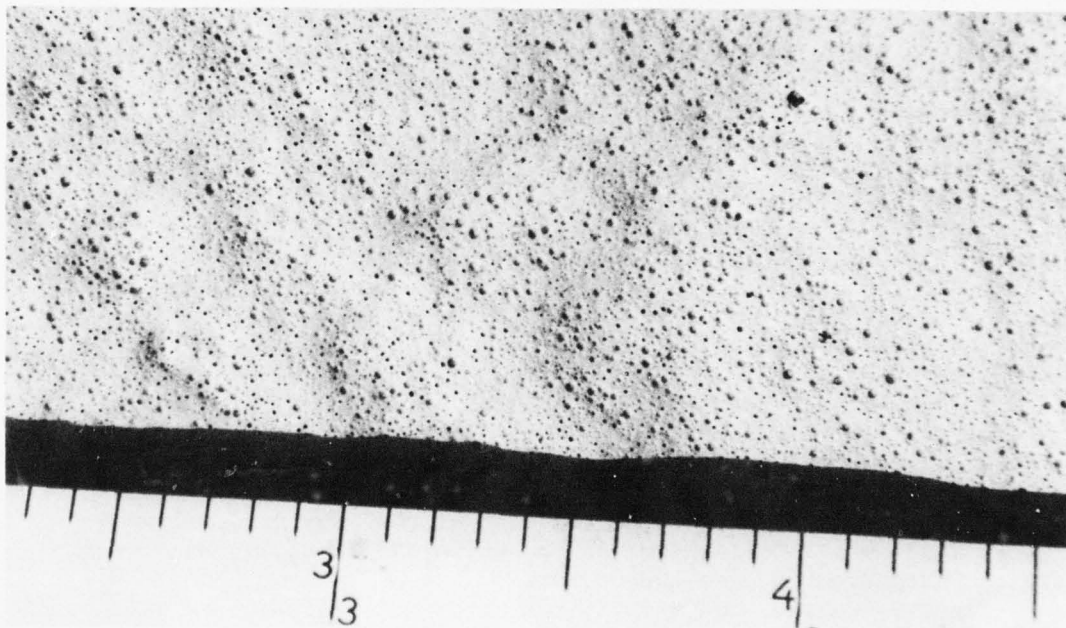
(a) Immediately After Coating

(b) After 18 Months of Weathering

Figure 41. Pinholes in Catalyzed Butyl-Hypalon (System 5)
